Study Report

SR440 [2020]

Escape route pressurisation systems: A pilot study of New Zealand data

Kevin Frank, George Hare and Colleen Wade

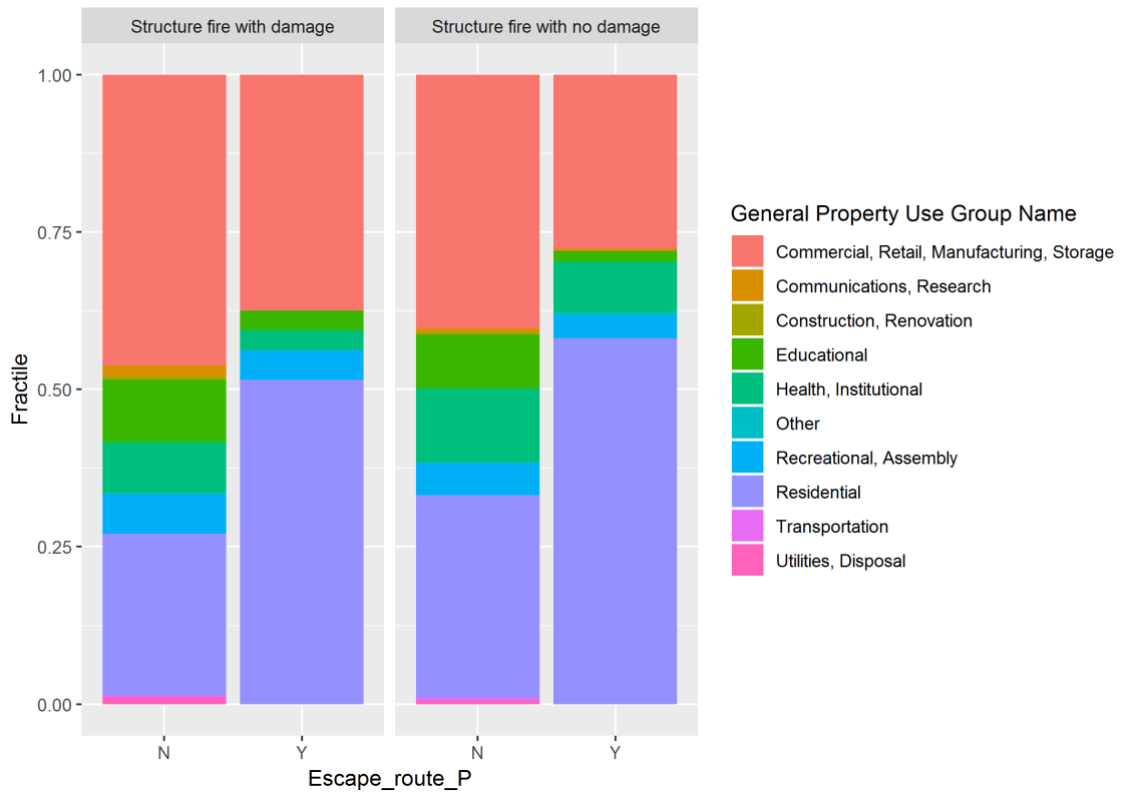
Figure 1. General building classifications.

The breakdown of general building types is shown in Figure 1. Pressurisation systems are more commonly found in residential buildings when compared to the general building population. Figure 2 shows that sprinklers were much more likely to be the fire detector when damage was reported. As would be expected, alarm levels (representing the amount of fire service resources required) were higher when damage was reported

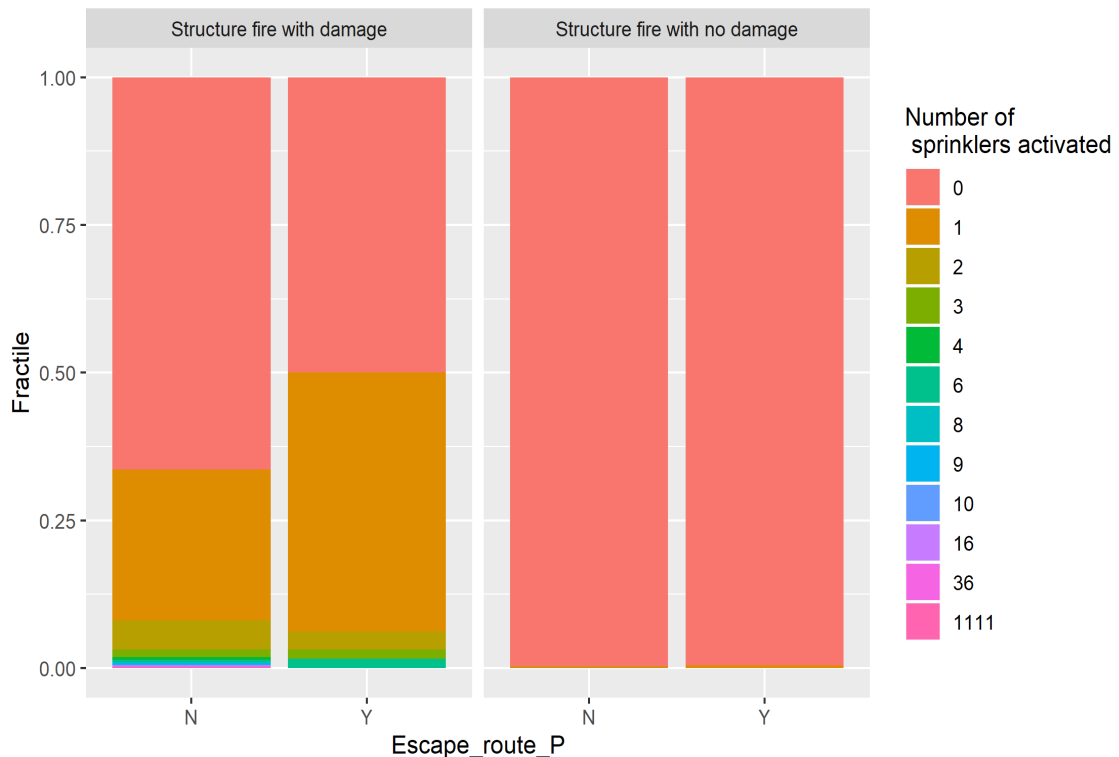
Figure 5. Sprinklers activated.

Figure 5 shows the recorded number of sprinklers activated. There were no “structure fire with no damage” incidents that recorded any sprinklers activated, as may be expected. A larger fraction of “structure fire with damage” incidents had sprinklers recorded as activated where buildings had pressurisation systems and with fewer numbers of sprinklers reported activated. This is consistent with the fact that a higher fractile of incidents in buildings with pressurised systems occurred in residential buildings. Residential buildings are typically more highly compartmentalised and with relatively small compartments, so fewer sprinklers would be expected to operate. While the fraction of buildings either with pressurisation systems or without that have sprinklers installed is unknown, it is considered likely that the fraction of buildings with pressurisation systems that have sprinkler systems may be higher when compared to all buildings. This observation is also consistent with the observation from Figure 4 that buildings without pressurisation systems were more likely to have fires where the arrival condition was reported as a “large fire”.

One incident reported 1,111 sprinklers activated in a building without a pressurisation system. Review of the dispatch report indicated that this was a sprinkler-controlled fire in a large, high ceiling height exhibition space. The correct number of sprinklers activated is unknown, likely to be multiple sprinklers but far fewer than 1,111 (i.e. it is probably a typographical error).

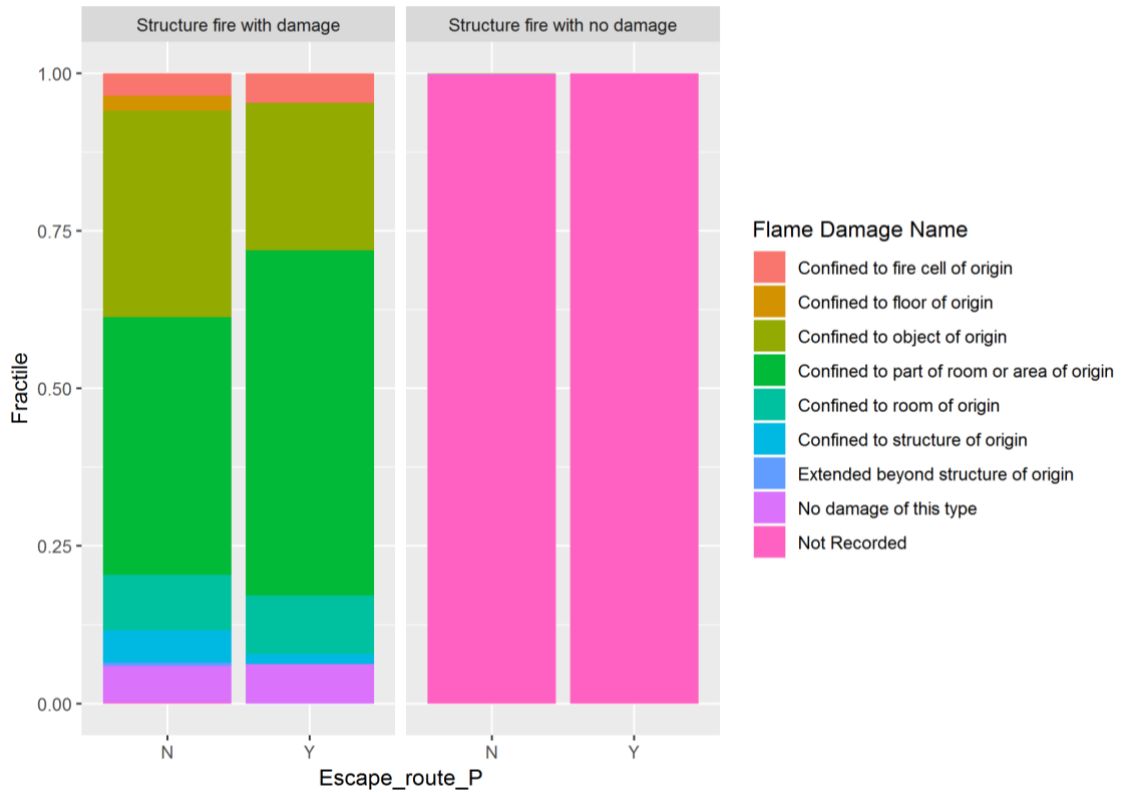
Figure 6. Extent of flame damage.

The extent of flame and smoke damage reported is shown in Figure 6 and Figure 7.
